AFWAL-TR-83-3084, Vol. II

**FATIGUE DAMAGE - STRENGTH
RELATIONSHIPS IN COMPOSITE
LAMINATES
VOL II**

K. L. Reifsnider and W. W. Stinchcomb

Final Report For Period December 1982 - April 1983

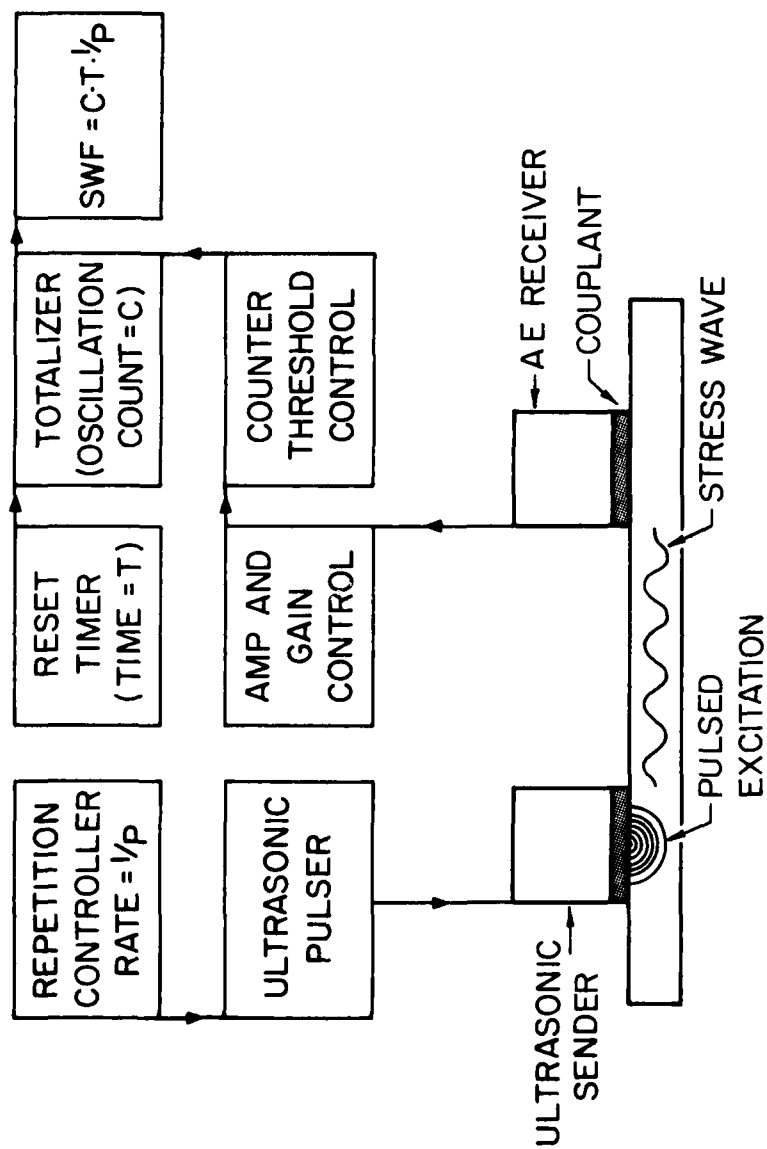
Fig. 4. Experimental arrangement for stress wave factor measurements.

$$SWF = ct(1/p) \quad (1)$$

where c is the number of oscillations, t is the period of time over which the counting is done, and $1/p$ is the repetition rate at which the sending transducer is emitting pulses. The SWF has many unique features, one of which is its sensitivity to the structural configuration of the object, i.e. lamina interfaces, lamina orientations, and boundaries which are manufactured into or created in the laminate. Because of this latter feature, it is possible to interrogate the material in specific directions which are of special interest, such as the direction of the applied load. One might expect regions which are poor conductors of information from one ultrasonic transducer to the other might also be "poor performers" relative to

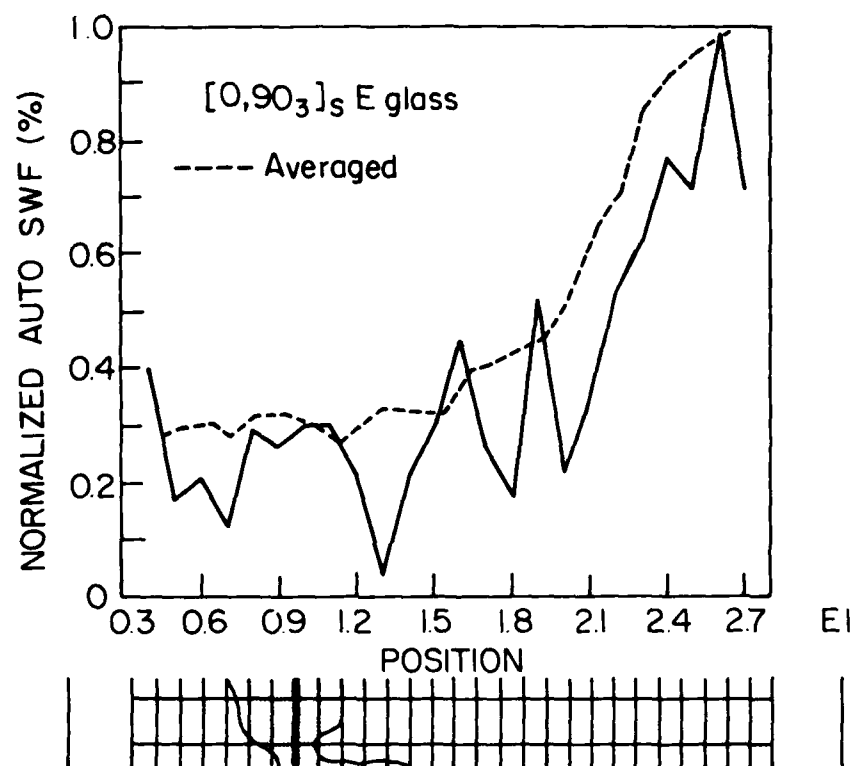
Fig. 5. Stress wave factor data compared to failure location (shaded) for a glass-epoxy specimen.

with this result [7]. These rather surprising results indicate that it may indeed be possible to locate the position at which a specimen will fail due to variations in internal integrity. It should be mentioned that these measurements were made on a specimen before deformation had occurred so that the correlations being made are correlations with the initial integrity of the laminates. This strongly suggests that, for a homogeneous applied stress state, the final location of fracture is associated with initial variations in the integrity of the material, a situation which may be interpreted in terms of the statistical variations in strength of various microvolumes of the material in general.

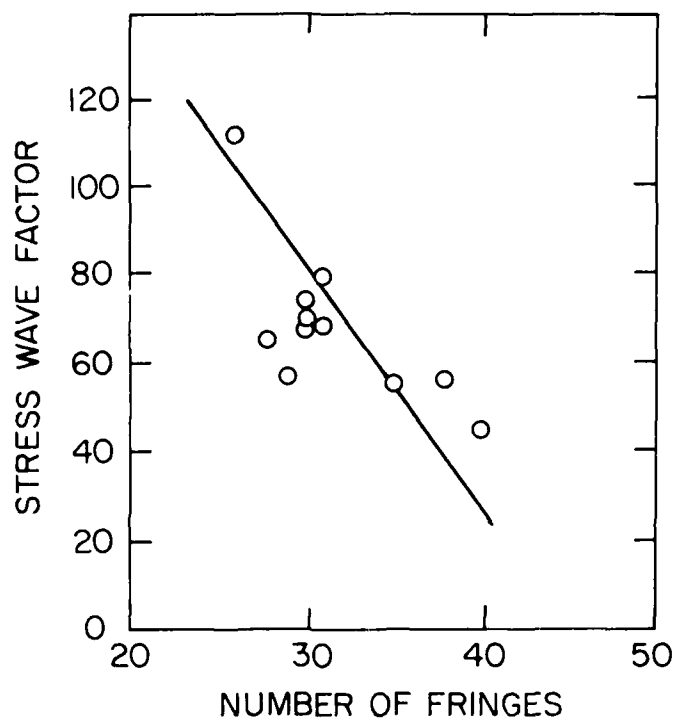
Fig. 6. Comparison of stress wave factor measurements with local stiffness implied from a moiré diffraction pattern.

These results are especially interesting when viewed in the context of their relationship to stiffness changes. A number of experiments were performed to compare the stiffness of as-manufactured laminates to the measured SWF values. The technique of moiré interferometry was utilized to obtain the full-field in-plane axial displacement during quasi-static tensile loading. Since the interference patterns obtained may be interpreted as displacement, it is possible to determine the stiffness as a continuous function along the length of a straight sided coupon specimen subjected to tensile loading. Figure 6 is an example of the data produced by comparing SWF values with axial displacement measurements. All results were recorded at load values for which no detectable damage was present. It appears that these measurements are correlated in some way. The region over which both measurements were taken was identical. The exact nature of the correlation is material and laminate dependent [7].

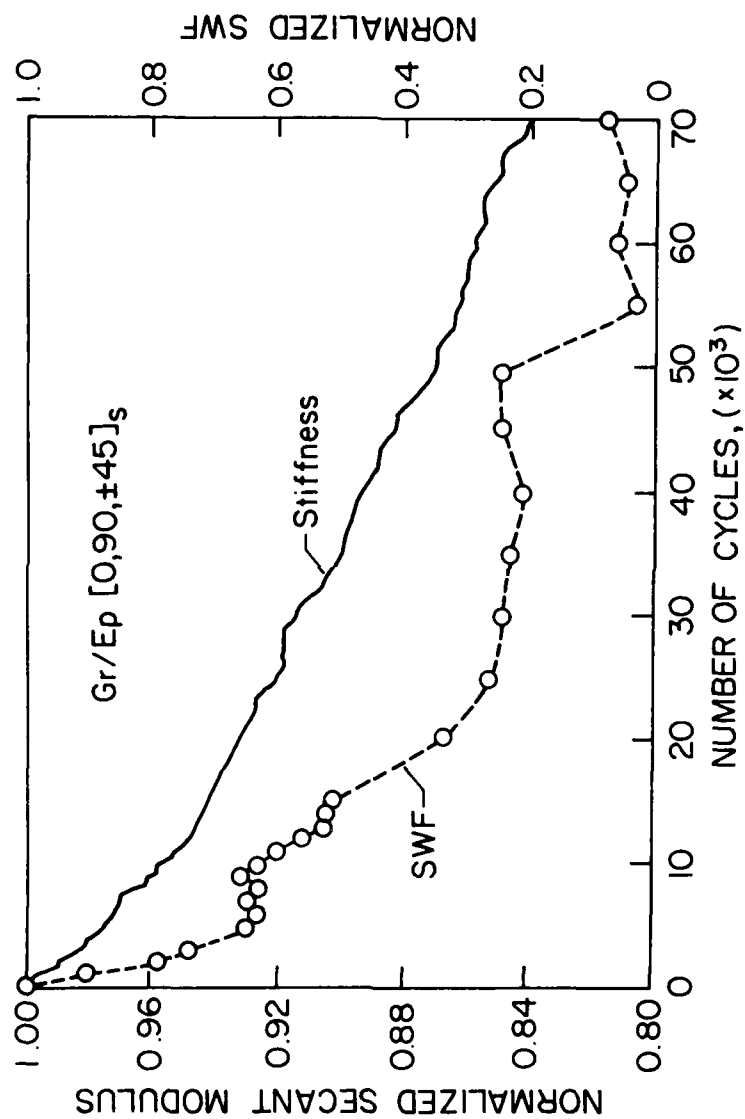
Fig. 7. Comparison of changes in SWF and axial stiffness of a fatigue loaded laminated composite specimen.

Since the SWF is sensitive to the internal integrity and structure of composite materials, it would be expected that damage development during cyclic loading would also produce changes in the values recorded with such a technique. That is indeed the case as illustrated by Fig. 7. That figure presents data recorded from a graphite epoxy quasi-isotropic laminate during tension-tension cyclic loading with a maximum stress of 62 percent of the static ultimate strength of that laminate. The (secant) stiffness of the laminate was recorded continuously during the cycling with a computer-aided real-time data acquisition device. A monotonic change of stiffness is shown and was discussed in Vol. I of this report. In that discussion it was indicated that the stiffness changes are produced by three rather distinct types of activity which occur in three different regions over the life of the specimen. The SWF is also seen to demonstrate a monotonic decrease and also shows three rather distinct regions of behavior. The early stage of behavior up to about 15,000 cycles of loading can be thought of as an initiation stage where transverse cracks form and eventually saturate in density to create a "characteristic damage state" for matrix cracking as discussed earlier. In the second region, damage growth occurs usually at ply boundaries, induced and driven by the local stress fields at those boundaries that are created by the matrix cracks in the off-axis plies. The region over which that activity occurs can be seen to be between about 15,000 cycles and 50,000 cycles of loading. The final stage of damage involves delamination that initiates along the edge of the specimen and begins to grow into the interior and is seen to occur between about 50,000 and 70,000 cycles which was the fracture point of this test. The SWF factor is seen to be sensitive to these different

types of damage and shows the changes somewhat more explicitly in this case than the single component of stiffness that was measured in that test.

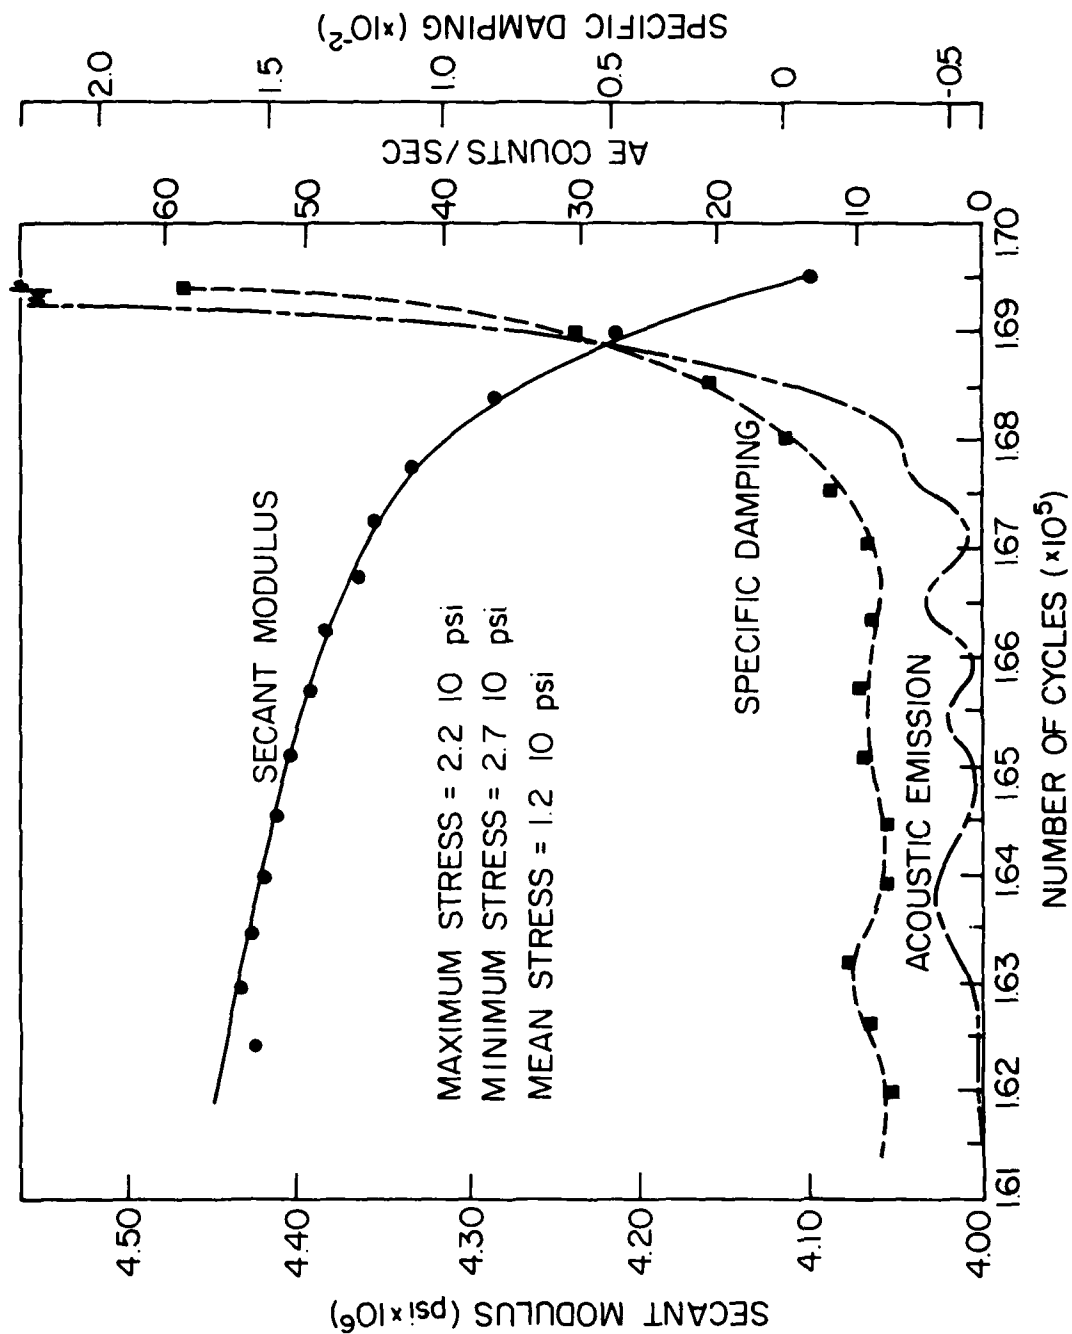
Fig. 8. Correlation of several types of nondestructive test data for a fatigue loaded $[0,90_2]_s$ glass-epoxy specimen.

Another correlation with other nondestructive testing data is illustrated in Fig. 8. That test was conducted on a $[0,90]_{25}$ S-2 glass epoxy specimen at the mean stress indicated on the figure. The first part of the test data was truncated for purposes of illustration so that the initial region of damage development is not seen. A second and third stage of damage development (also discussed in Vol. I of this report) are evident. The third stage of damage development involves, in this case, longitudinal splitting which induces severe damage and eventual fracture of the specimen. The initiation of that damage stage and its progression are clearly indicated by the ultrasonic attenuation (specific damping), acoustic emission rate and secant modulus change. In fact, incipient fracture is clearly indicated by all three of these nondestructive test techniques. Of course, it is still not completely clear how to interpret the information obtained and the specific damping and acoustic emission data in terms of the specific details of the internal damage events that are occurring. While that is also true of the secant modulus results, a number of models have been developed which do relate those data to some of the mechanisms of damage development and to the degree of that development. By using several nondestructive test techniques which are sensitive in a discriminatory way to the details of damage development during cyclic loading of a laminate, it is possible to obtain more information than one could extract from any one of the single techniques alone, and more than one could create from a simple combination of information from those techniques.

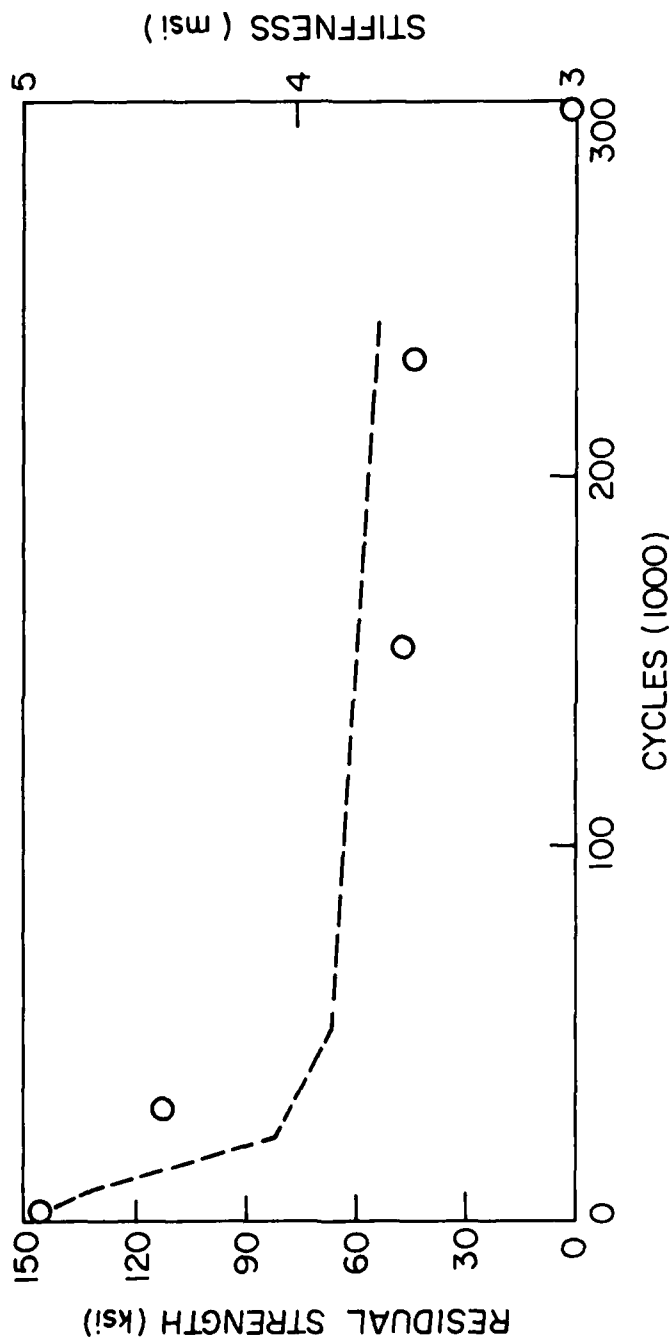
Fig. 9. Residual strength (open circles) and stiffness changes (dotted line) for a series of fatigue tests on glass-epoxy specimens.

Another interesting result regarding the use of nondestructive testing methods for the determination of life and residual strength is illustrated in Fig. 9. The dotted line in that figure is a recording of the continuous change of the secant modulus during the loading of a $[0,90]_{2s}$ S2 glass epoxy specimen with a maximum (tension-tension) amplitude of about 30 percent of its static ultimate strength which produced a lifetime of about 300,000 cycles. The initial strength of such a specimen is recorded as 150 ksi. Subsequent specimens were fatigue-loaded at the same level of stress and the tests were terminated at the numbers of cycles which correspond to the positions of the open circles on the abscissa. At that point, residual strength tests were run on those specimens and the data are indicated by the open symbols in Fig. 9. The scales of stiffness change and residual strength have been adjusted in order to emphasize the correlation between the residual strength and stiffness change for the specimens tested. It is clear that there is a strong correlation between the change in residual strength and the change in stiffness as these specimens are cyclically loaded. During the course of this investigation, a variety of other such correlations have been noted [1,3,8-16]. This kind of correlation strongly suggests that stiffness change can be used as an indicator of the consequences of the accumulation of damage and the amount of remaining strength in a specimen which has been fatigue-loaded. It also suggests that an understanding of the final fracture event should be closely related to an understanding of the exact manner in which the complex internal damage development process changes the residual stiffness of a composite laminate.

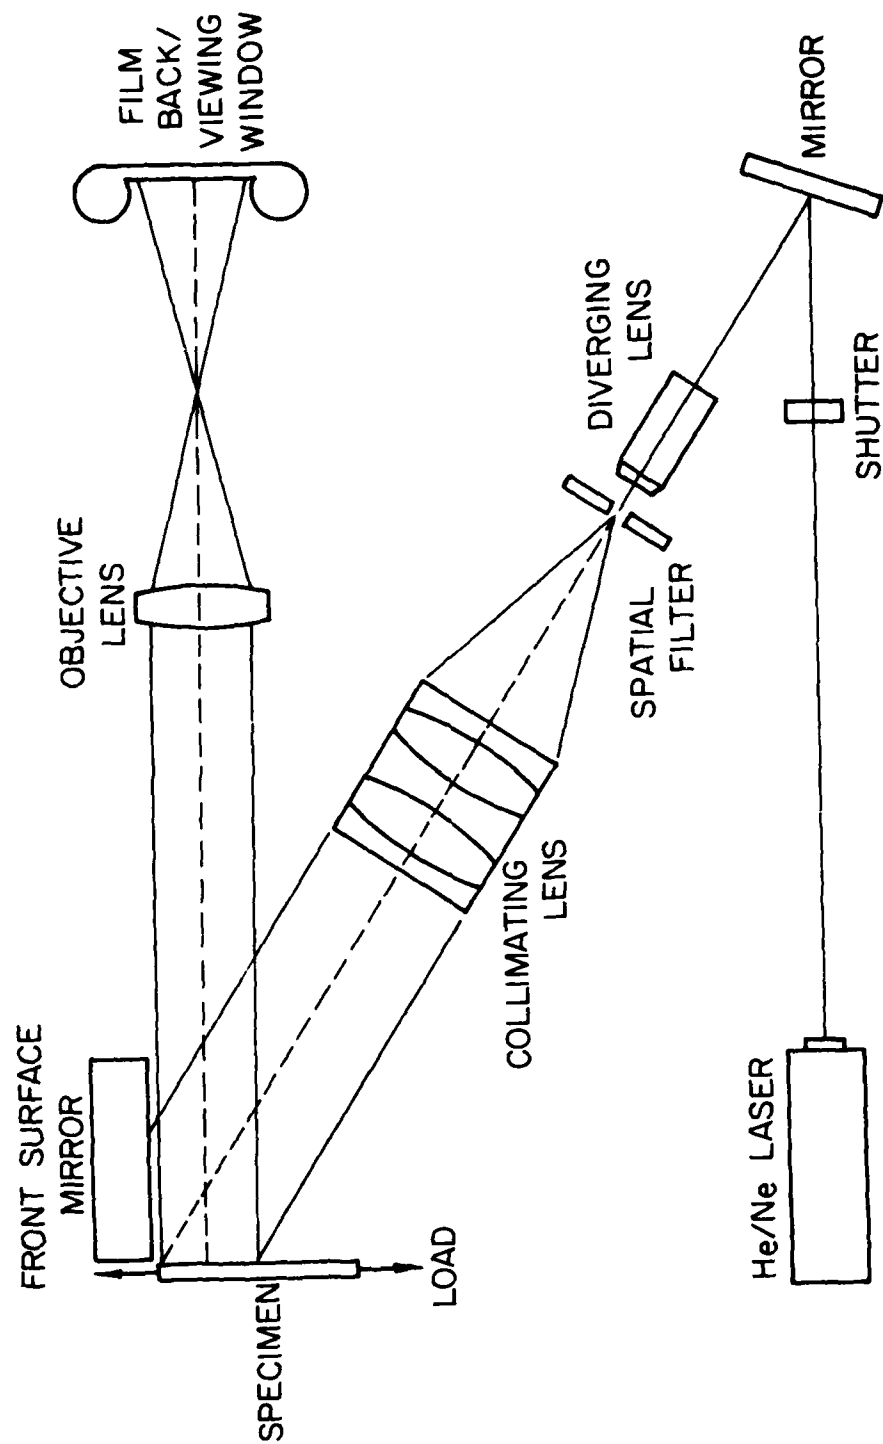
Fig. 10. Schematic of experimental arrangement for moiré diffraction investigations.

In our moiré interferometry apparatus, all of the elements shown in Fig. 10 except the specimen and its active grating, are attached to a mounting plate. A 5.0-mW helium-neon laser provides a beam of coherent monochromatic light. The laser beam is reflected by a front-surface mirror through a diverging lens. A spatial filter, consisting of a pinhole, is placed at the focal point to block out all light but that from the uniform intensity core of the beam, thus increasing the uniformity of the diverged beam. The diverging beam passes through a collimating lens, and is thus transformed into a parallel (and expanded) beam of light.

A silicone rubber grating with a frequency of 600 lines/mm is bonded to the specimen surface. The grating lines are perpendicular to the load direction. The collimated light is oriented with respect to the specimen so that the first-order diffraction of this light off the specimen grating is normal to the specimen surface. A portion of the beam is reflected by a front-surface mirror onto the grating so that both it and the direct beam, and thus their respective first diffraction orders, are symmetric about the normal to the specimen surface. When the grating is undeformed, the two first-order diffractions are parallel to each other and the phase difference is spatially constant. When the specimen (and grating) is deformed, the grating frequency is changed, which in turn alters the angle of diffraction of the two beams, and the phase difference between them varies spatially. The interference of the two first orders produces a series of light and dark fringes

(constructive and destructive interference fringes) that correspond to contours of constant relative displacement (constant phase difference between the two diffracted beams) in the load direction. Because the interference pattern is formed by two first diffraction orders, the successive contour lines differ in displacement by $1/1200$ mm. (A more detailed discussion of moiré interferometry appears in Ref. [17]).

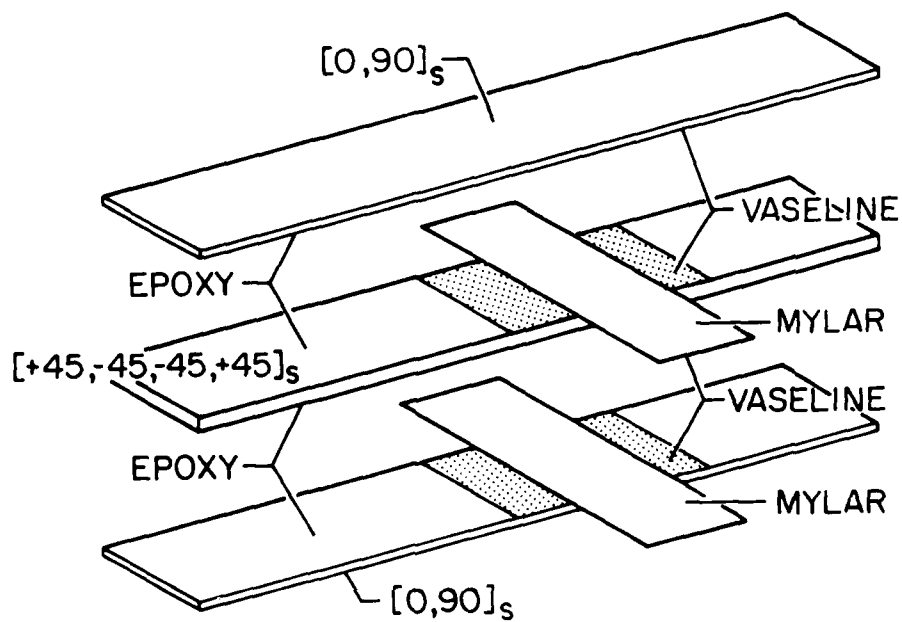
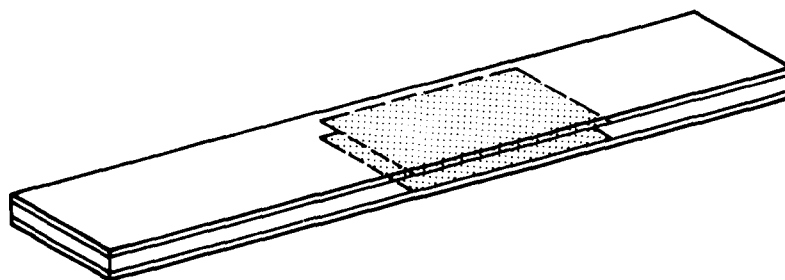
Fig. 12. Method of construction of controlled regions of delamination for stress redistribution studies.

Another example of the utility of the moiré scheme for the measurement of inhomogeneous micro-strain is provided by our study of the redistribution of stresses caused by delamination. In order to investigate the effect of delamination on laminate response, a specimen with an artificial delamination was fabricated. Three pieces of T300/5208 graphite epoxy 254 mm long x 38.1 mm wide were bonded together using Miller-Stephenson type 907 two part epoxy adhesive. As shown in Fig. 12a, the two outer layers were $[0,90]_s$ material, while the central layer was $[+45,-45,-45,+45]_s$ material. A 50.8 mm long region on each of the mating surfaces was coated with vaseline before the adhesive was

applied. During assembly of the specimen, a 38.1 mm wide strip of mylar film was placed on the center of the vaseline coated region of each interface. After curing the adhesive, the mylar strips were removed, and the laminate was trimmed to 25.4 mm in width. The resulting specimen, shown in Fig. 12b, contained 50.8 mm long delaminations in the 0/45 interfaces which crossed the entire width of the specimen and were aligned along its length.

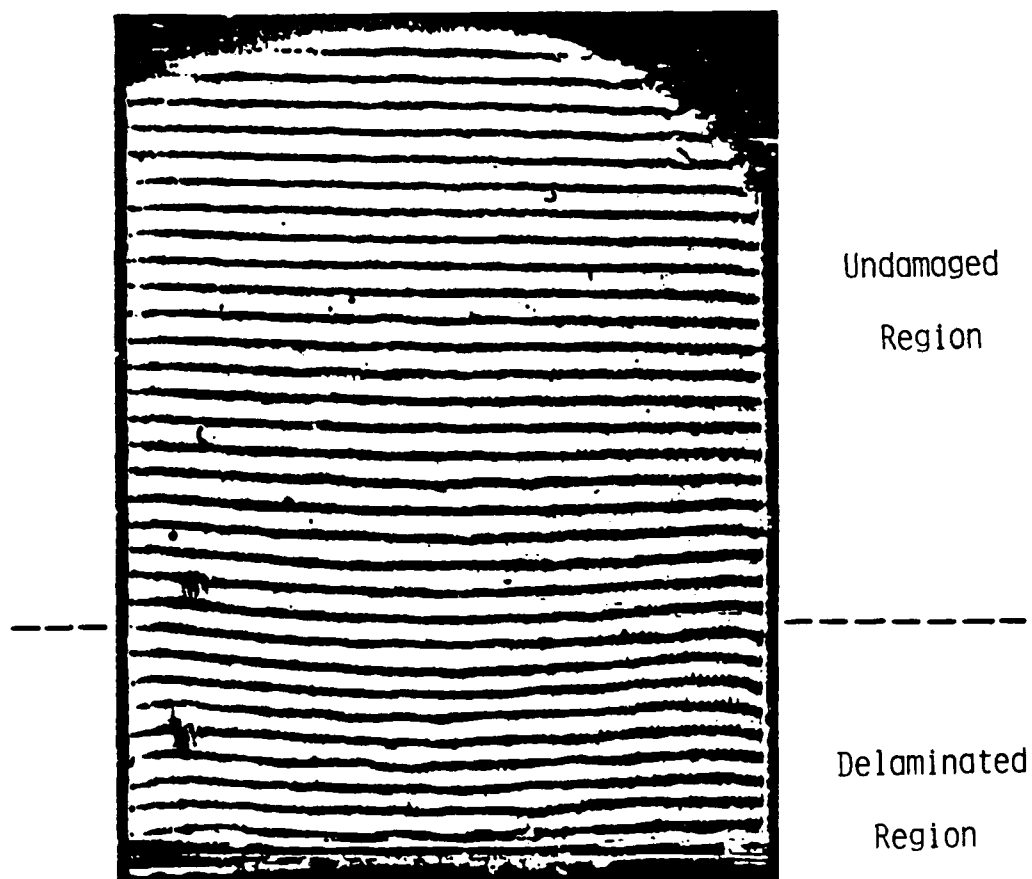
Figure 13. Moiré fringe pattern taken from specimen SC-1 spanning both undamaged and delaminated regions.

A moiré fringe pattern, Fig. 13, obtained from this specimen indicates how the delamination influences material response. Again, each fringe is a contour of relative axial displacement. In the undamaged region, the fringes are straight and uniformly spaced. In the delaminated region the fringes are curved, and are also closer together than those in the undamaged region. The difference in fringe density indicates that the axial strain is greater in the delaminated region. This difference in strain arises because the three layers are not constrained to have the same transverse and in-plane shear strains in the delaminated region. The Poisson's ratio mismatch between the two types of layers causes the distributions of stresses in the two regions to differ. This also explains why the moiré fringes are curved in the delaminated region. The transverse constraint relaxation takes place more readily near the specimen edge, and thus the transition from undamaged to delaminated response occurs over a shorter distance. Away from the edge near the delamination front, the delaminated layers are still somewhat constrained by the surrounding material. A simple stress analysis using laminate theory can be performed to estimate the effect of delamination on internal stresses. In this analysis, the three layers in the delaminated region are required to have equivalent

longitudinal strain, but no restrictions are imposed on the transverse and shear strains. Equilibrium requires that the delaminated and undelaminated regions are subjected to the same total load. The predictions of in-plane stresses in each ply of both the delaminated and undamaged regions are presented in Table I. Note that σ_x in the zero degree plies is larger in the delaminated region, as indicated by the moiré pattern. Using a one in. gage length clip-on type extensometer, local axial strain response was monitored in both the undamaged and delaminated regions. This data is presented in Fig. 14. (Load was chosen instead of stress because the material cross-sections in the delaminated and undamaged regions differ by 2 thicknesses of epoxy adhesive. However, the adhesive is relatively compliant so this discrepancy should not significantly affect the results). The reduction of axial stiffness due to the delamination was observed to be 14.3 percent. The simple analysis discussed above predicts a 12.7 percent reduction in stiffness.

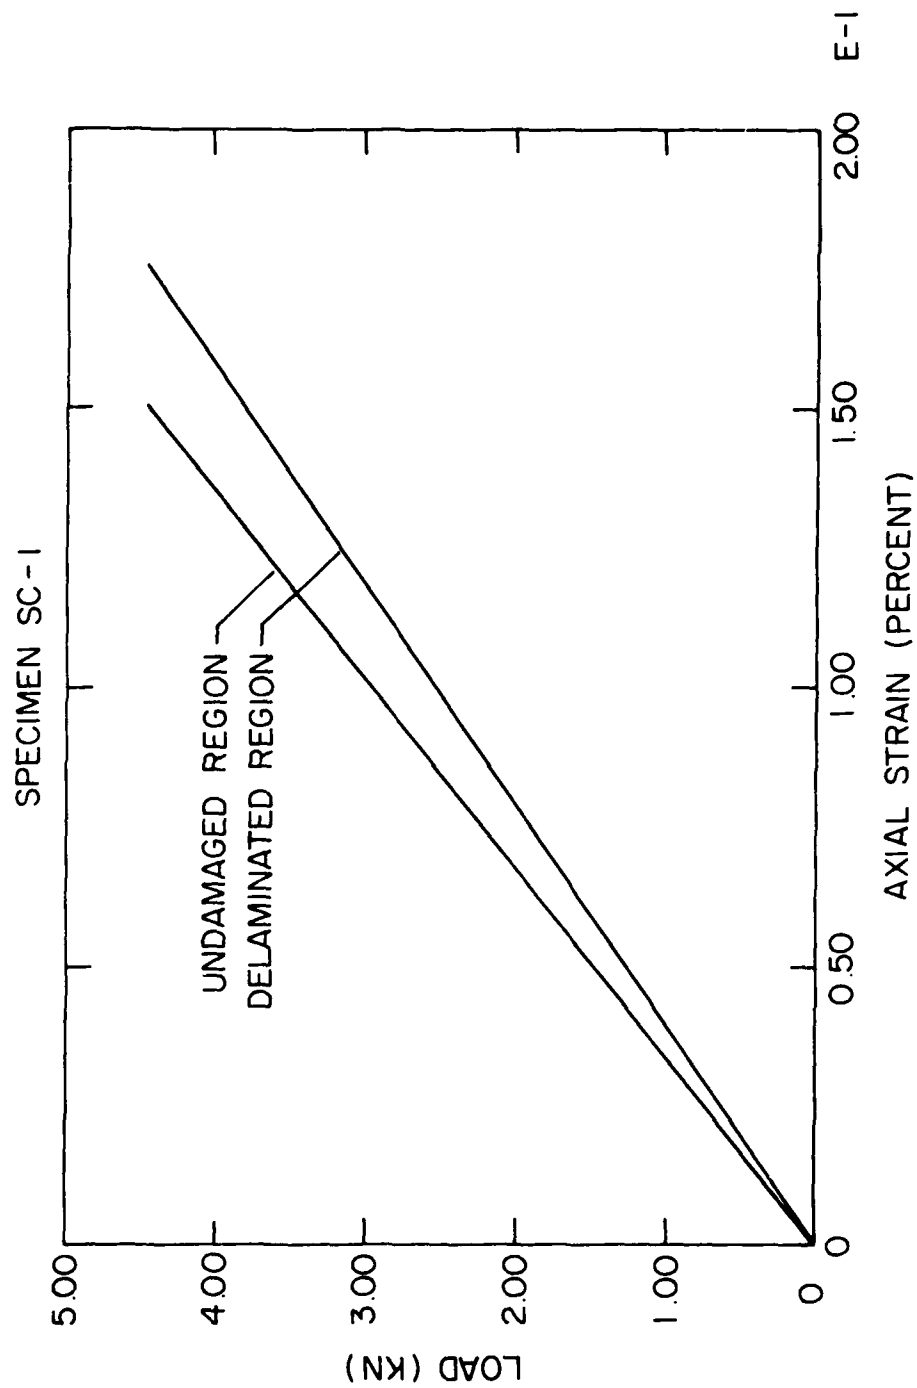
Fig. 14. Comparison of specimen effective stiffness in delaminated and undelaminated regions.

both a 25.4 mm gage length clip gage that spanned just the delaminated zone, and a 50.8 mm clip gage that spanned both the delaminated region and undamaged material. While no measurable difference in stiffness was detected (or predicted) the average reduction in tensile strength from that observed in specimens without delaminations was 25.4 percent. This is nearly the reduction in strength that would be expected if the interior plies carried no load. It is possible that other damage is coupling with the delamination and mechanically separating the zero degree plies from the interior plies.

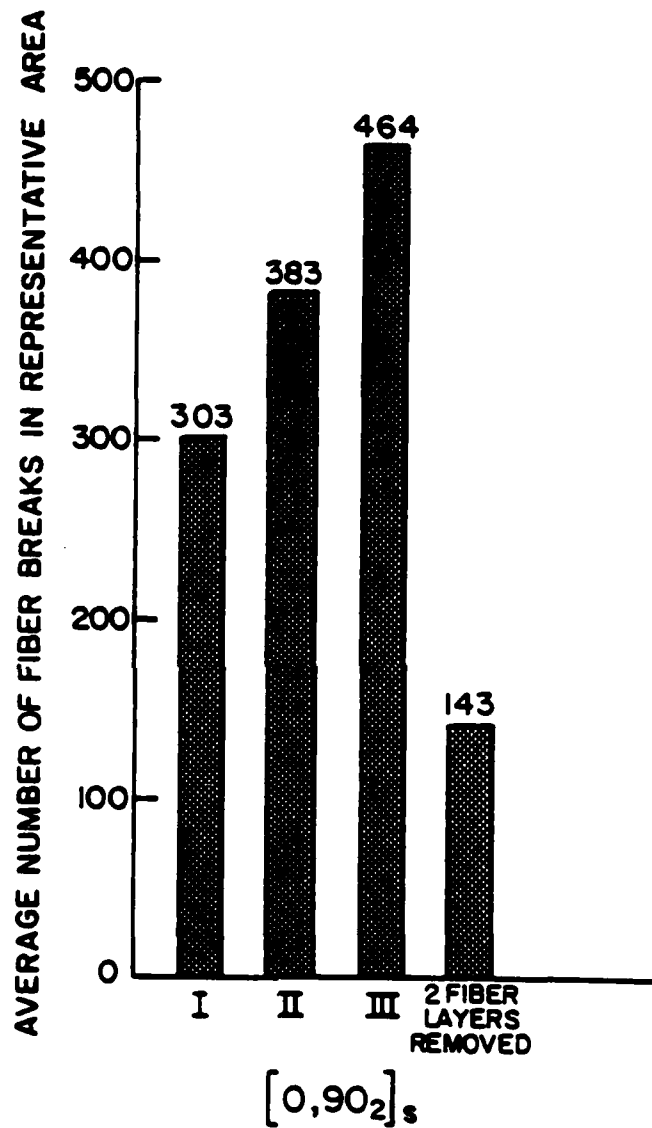
Figure 15. Average number of fibers broken in a fixed area of viewing at about one-third, two-thirds, and nearly one full lifetime of cyclic loading for a graphite epoxy laminate.

One way to illustrate the existence and nature of a fiber fracture process is to consider the information given in Figs. 15 and 16. The data in those figures was developed from a destructive, microscopic technique developed by Freeman [18]. In this method, the specimen is heated to a temperature sufficient to partially pyrolyze the resin matrix. The interlaminar bond strength is thereby diminished to the extent that the individual plies of the laminate can be separated. The heating was accomplished in an electric tube oven in an argon gas environment. Sufficient resin material remains after pyrolysis to hold the plies together if they are handled carefully. Introduction of an enhancing agent along the edges of a specimen prior to the deply procedure served to enhance the internal regions of damage for ease in visual identification, much in the manner of X-ray image enhancement by opaque material. The separated plies were examined by both light and

In Fig. 15 it is seen that for the $[0,90_2]_5$ laminate under fatigue loading, the number of multiple fiber fractures increases as a function of the number of applied cycles of loading. (The last column of data in Fig. 15 was developed by removing two fiber layers from the zero degree ply under observation and making a recount of the fiber fractures observed.) The I, II, and III indicate stages 1, 2, and 3 of the test as discussed in earlier reports and can be regarded, for the purpose of our present discussion, as roughly one-third, two-thirds, and the final third of test time. For the data that was obtained just prior to fracture of the specimen, the distribution of data obtained was 78 percent singlets, 17 percent doublets, 3 percent triplets, and 2 percent higher order multiplets for the test shown. The highest order multiplet observed was 8. For comparison purposes it can be noted that the same type of laminate was observed near static failure and a distribution having 90 percent singlets, 8 percent doublets, and only 1 percent each of triplets and higher order multiplets was observed. In that instance for quasi-static loading the highest order multiplet observed was 4. Hence, not only is the number of total fiber fractures and order of magnitude greater for fatigue loading than for quasi-static loading, the number of fibers that break in close proximity to one another is also much larger for cyclic loading than for the quasi-static case. Hence, it is clear that there is some process of fiber fracture development during the cyclic loading experience, a process that seems to involve the development of fiber fractures which are in the neighborhood of fibers that break at an earlier time. Figure 16 shows an interesting

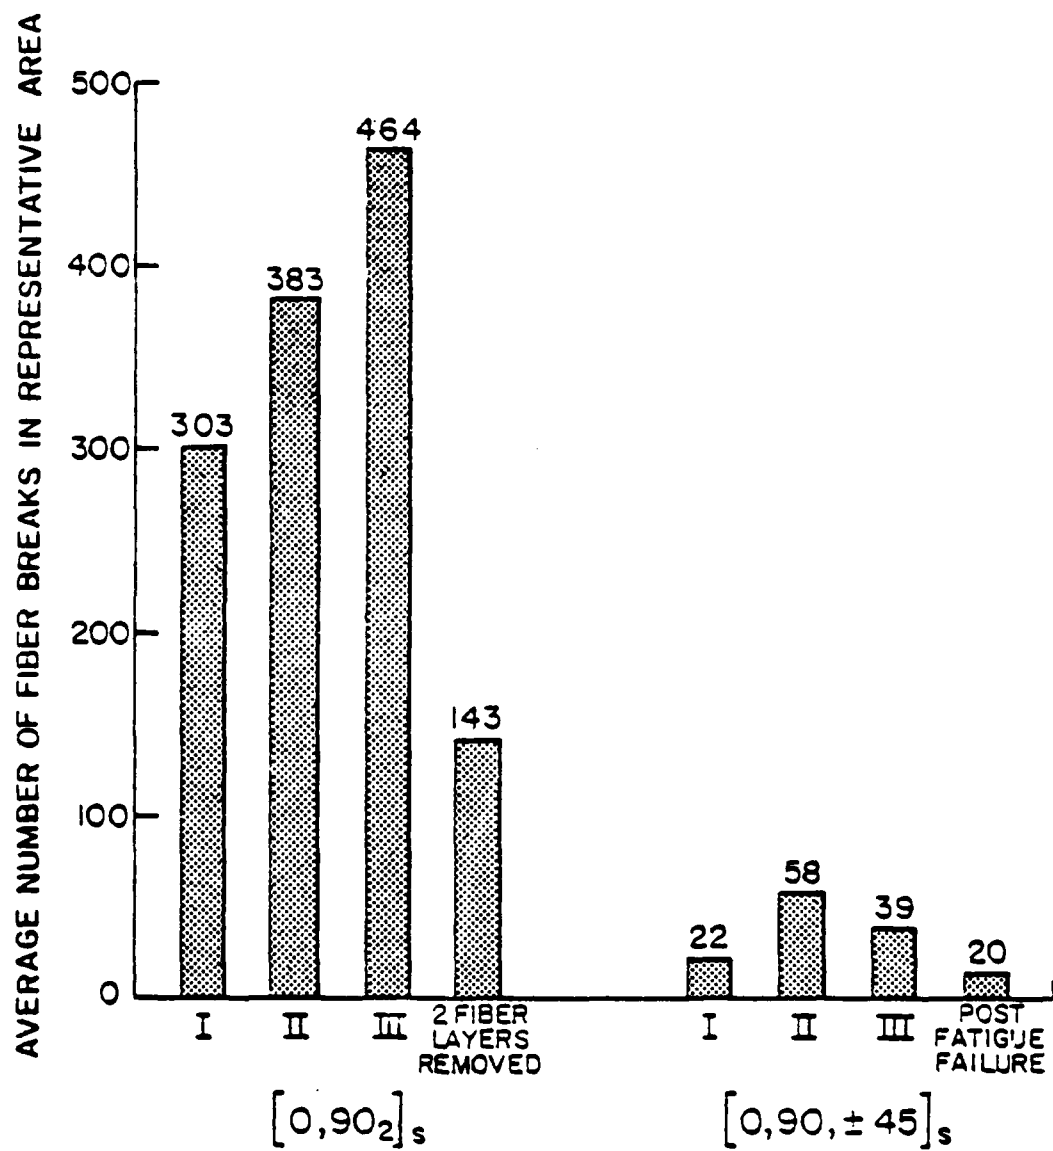
Figure 16. Total Fiber Fractures in $[0,90,\pm 45]_s$ Laminates.

comparison between the quasi-isotropic laminate and the $[0,90_2]_s$ laminate discussed in Fig. 15. For the quasi-isotropic case at incipient failure the distribution of fiber failures consists of 85 percent singlets, 7 percent doublets, and 8 percent triplets. The highest order multiplet observed was 3. The difference between the number of fibers that fractured during cyclic loading of the quasi-isotropic laminate and the quasi-static loading case for that laminate was smaller than for the previous laminate stacking sequence; approximately 4 times the number of fibers that failed in the quasi-static case were observed in the fatigue case. In that context it should be mentioned that the global zero degree ply stress at laminate failure was 22 percent higher for quasi-static loading than for the fatigue data developed and shown in Fig. 15, while the difference was only 7 percent between the quasi-static and fatigue failure amplitudes for the data representing the quasi-isotropic laminate in Fig. 16.
